PIMA COMMUNITY COLLEGE

# DRACHMAN AREA FEASIBILITY REPORT

JULY 26, 2019 | BWS PROJECT NO. 1827

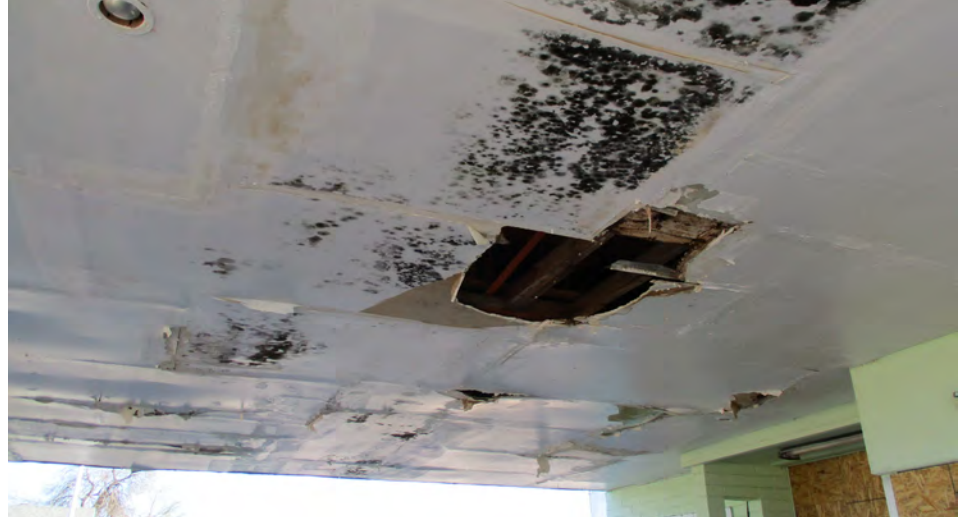
**Ceiling at  
porte-cochere**

The front drive canopy was mostly covered by ceiling framing. Access to the roof was not provided. Several areas of roof leaks were observed in the canopy ceiling. Due to the extent of the roof leaks we would anticipate there is some water damage to the roof framing structure that will need to be repaired or replaced.

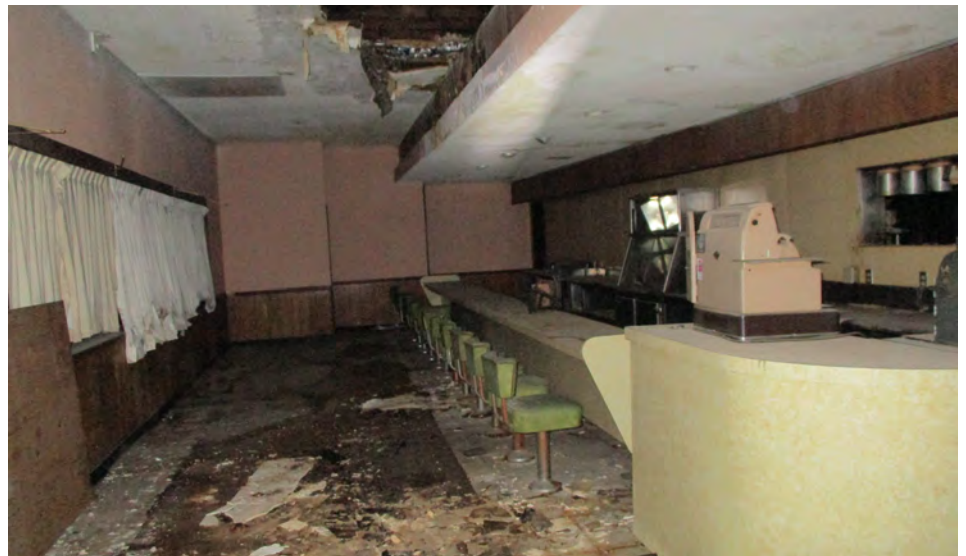
**Café with collapsing  
ceiling, mold, wet floor**

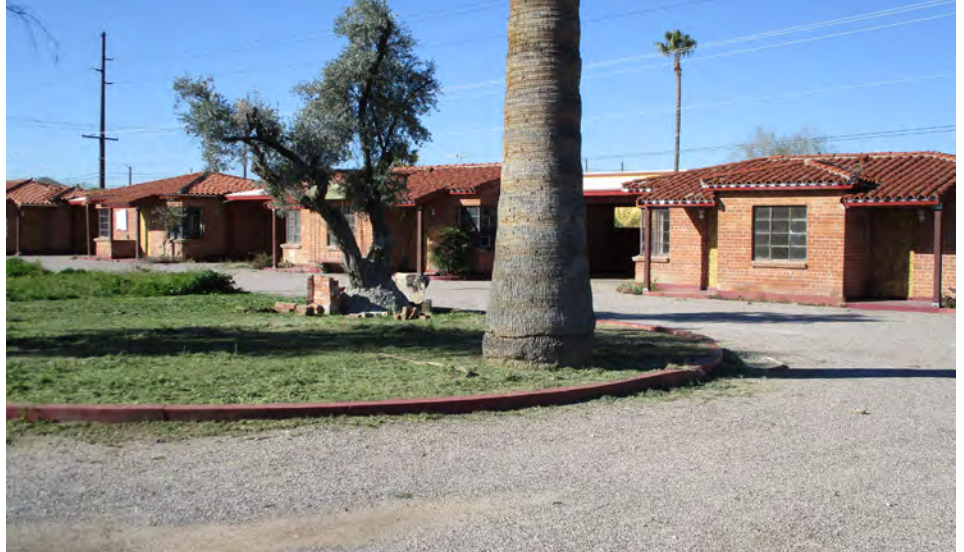
**Bungalows on west end  
with carports between  
Landscape area**

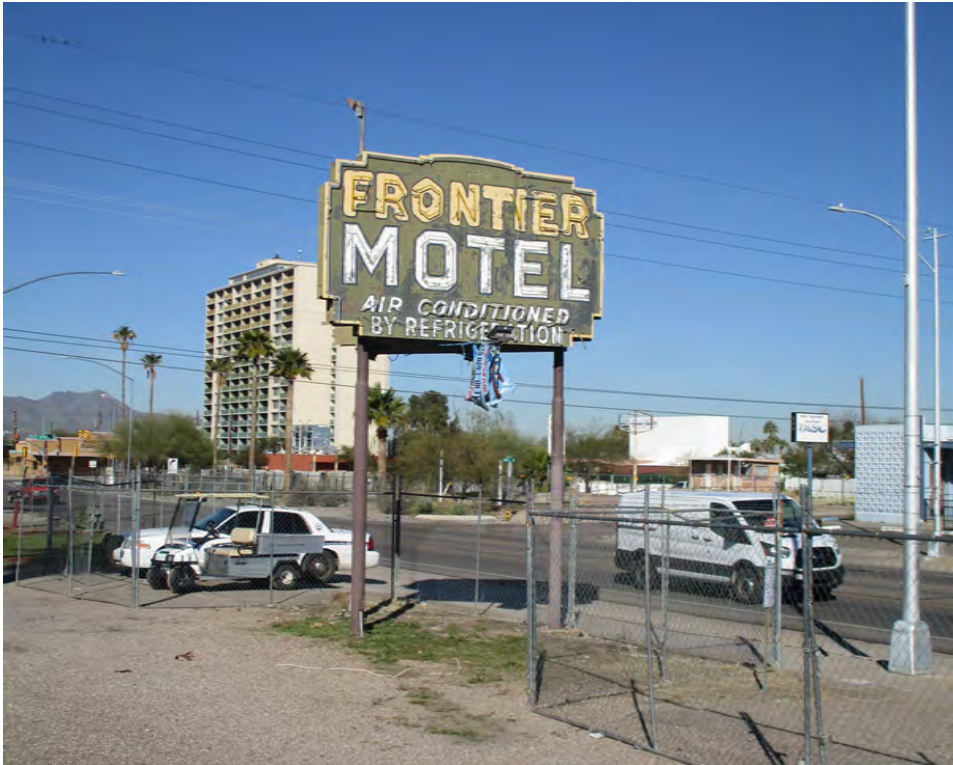
The buildings are suffering from not being occupied – there is large scale graffiti occurring, but are generally in very good condition, and as previously noted, have evidence of recent ongoing maintenance. The original sign is still in place and Could be renovated to add to the college’s collection of historic neon.

**Original historic sign – two faces joined together at the street end**
