PIMA COMMUNITY COLLEGE

# DRACHMAN AREA FEASIBILITY REPORT

JULY 26, 2019 | BWS PROJECT NO. 1827

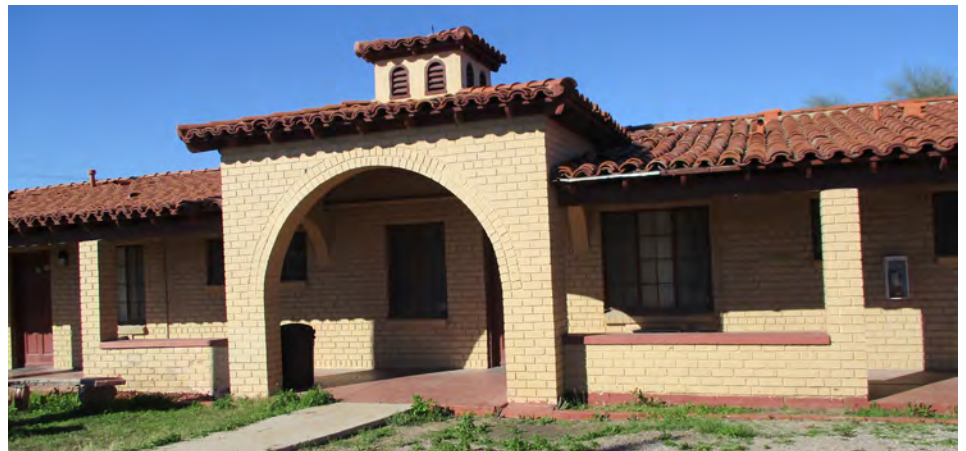
The buildings are constructed of brick, which has been painted, a wood roof structure with projecting joist ends (to imply vigas), and clay barrel mission tile roofing. The rooms on either side of the central court have an arcade that runs the full length of each wing, with arched entries, and low walls. There is a tower element at the north end of the west wing. Windows are single-glazed steel casements, typically rectilinear, though those at end walls facing the street are arched. The floors of the exterior arcades are red colored concrete slab on grade, with wood ceilings under the roof. Walls are likely uninsulated, with either plaster or drywall directly applied to the interior side of the brick. Floor consists of carpet in the sleeping area, vinyl sheet in the kitchen, and tile in the bathroom.

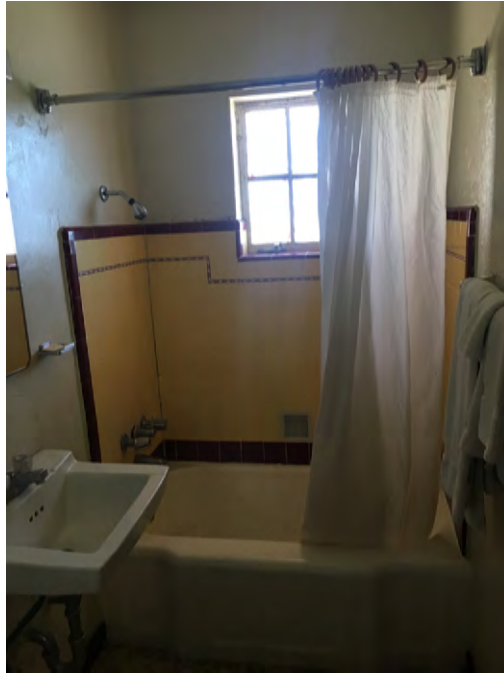
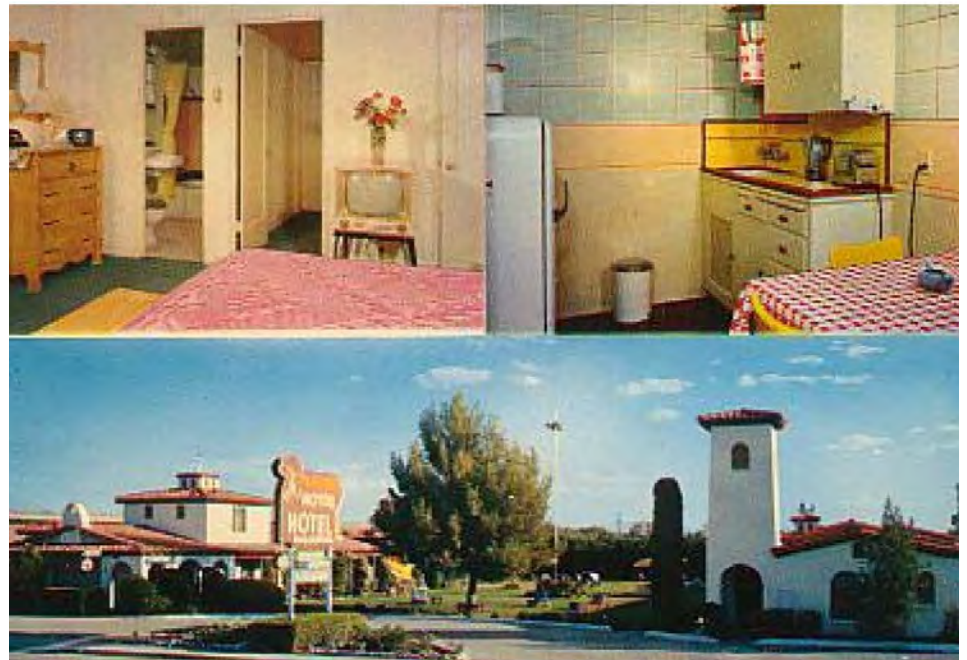
The original sign has been replaced, though it would be very good to reproduce the original sign if enough documentation could be found to do so. The postcard below shows the original sign, as well as the interiors of the suites.

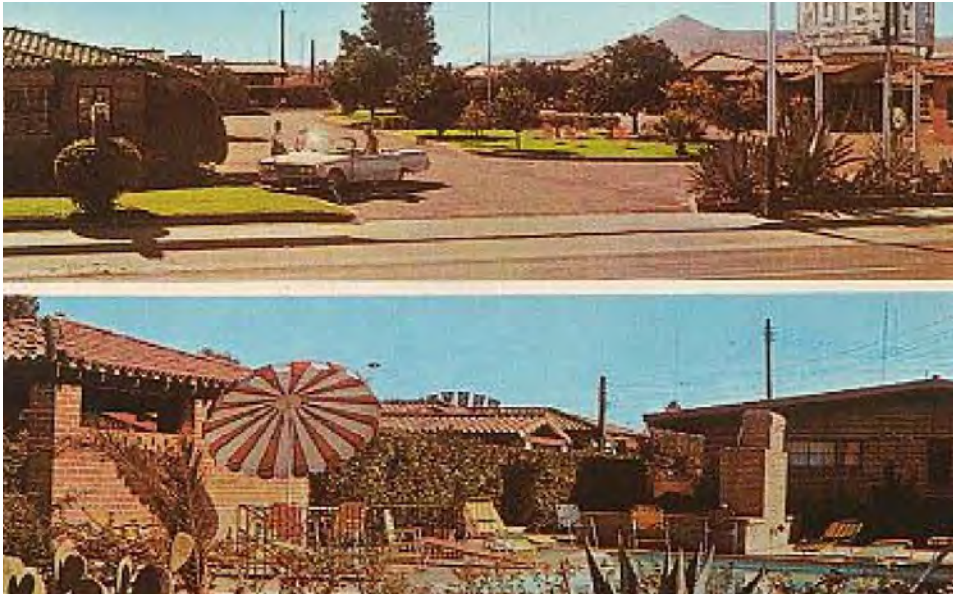
**Overall site above; pool area with fireplace below**

The site and buildings could be readily renovated, and systems updated, for a new use. As shown on the postcard below, the motel in its day was quite stylish and appealing, and could be so again.
